Stylus

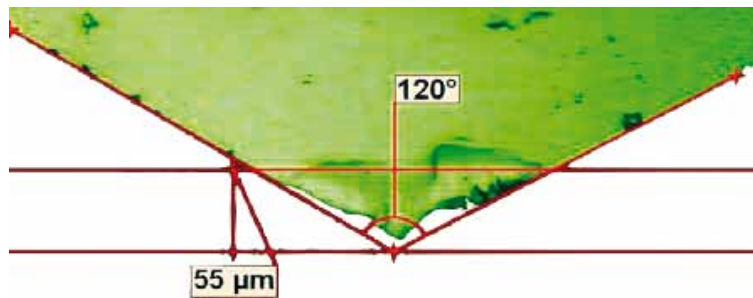
Normal wear which affects every mechanical tool is indicated by cratering off the stylus tip. Experiences and repeated stylus analyses have shown wears more at the side (middle section of the stylus) than on the tip itself. The structure of the diamond is the reason for this.

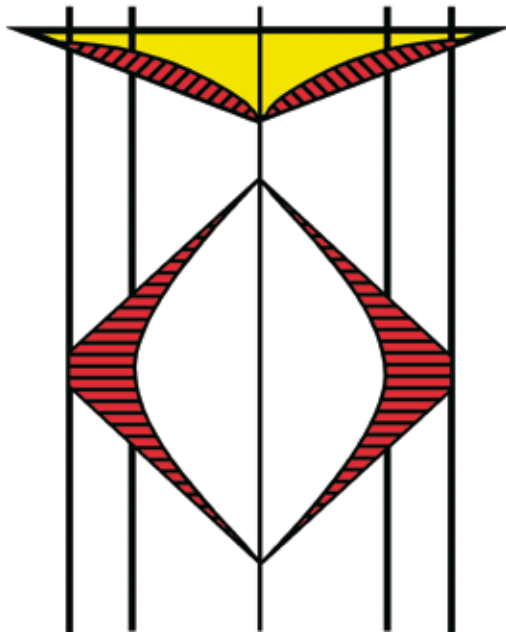
Indications of wear

When the test cut is made, it is no longer possible to achieve the target diagonal of the cell despite the default current setting for the engraving amplifier. The above described cratering on the sides of the cutting edge is therefore so advanced that with standard default current settings only a smaller cell is engraved.

It is also possible that although the target diagonal exists when the cells are measured, the specified printing density cannot be achieved in the proof print. In this case, the cratering at the sides of the stylus results in erosion of the stylus tip. This second scenario is considerably more unpleasant because it is not possible to detect flaws until the cylinder has been completely finished.

Normally in the case of worn styli, the loss in volume is due to a combination of inadequate cell depth and reduction cell diagonal. Wear solely due to tip erosion is very rare. In practice, it is possible to analyze the condition of the stylus using the test cut.

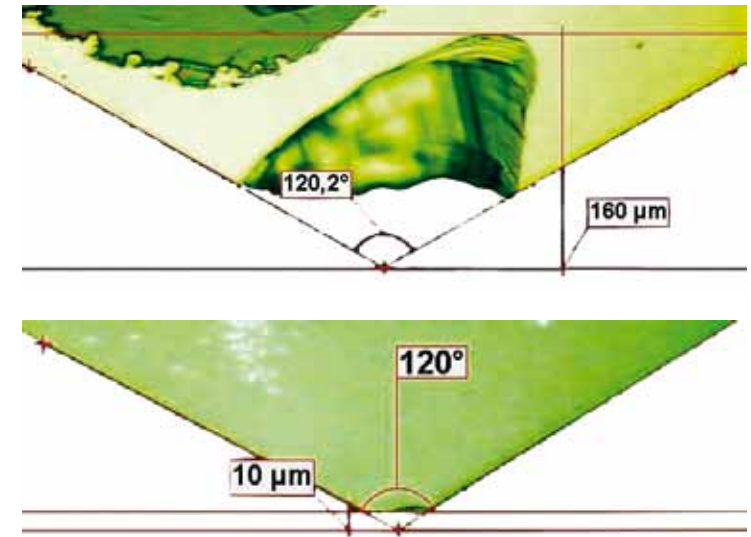
Broken tip

If the stylus tip is lost, the first printing tone can no longer be produced correctly. Screen cells in highlight areas are missing completely and higher tonal values have irregular cell edges. The cell volume is reduced, and the positive effects that the pyramid geometry has with respect to ink transfer are spoilt.

The results are insufficient printing density, loss of detail and uncontrolled variations in print densities. The diamond can no longer be used and must be replaced.

Broken tips result e.g. from incorrect setting at the engraving amplifier. It is often falsely assumed that high vibration values result in increased cell volumes.

In case of over-dimensional vibrations, the stylus does actually penetrate deeper into the surface of the copper and logically produces a higher lateral diagonal, but at the same time reduces the longitudinal diagonal. This results in only a limited increase in volume.

However, since the stylus penetrates more deeply than actually intended for the cut of the diamond, the rear “free” facets of the stylus hit the copper with each cut. Consequently the stylus is overloaded and will break prematurely! Impurities in the copper and excessive Vickers hardness also cause breakage. Its inclined position minimizes the risk of breakage.

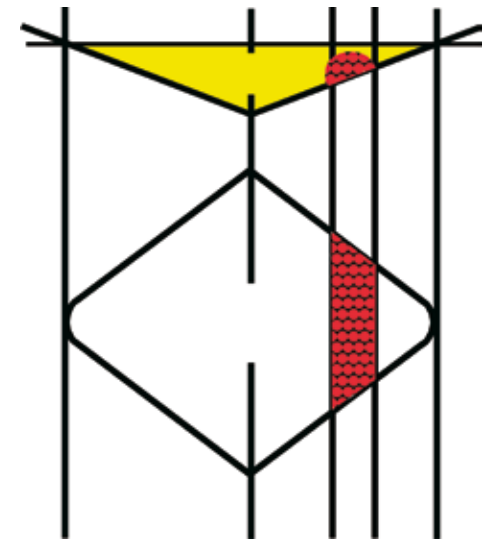
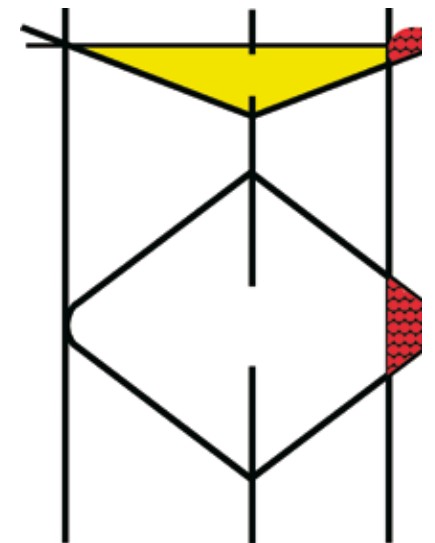
Coarse breakage

More severe damages to the cutting edges frequently result in unreliable measurement of the cell diagonal at cut cells.

This in turn makes adjustments of the engraving system more difficult. The cell configuration thus becomes asymmetrical and the absence of burr removal results in a reduction in volume. This causes a loss in printing density and shifts in gradation, especially in the light tones. Such styli can obviously no longer be used for high quality work.

The cutting diamond hits hard particles in the copper or the cylinder grinding residue (abrasive grit) or porous points (cavities) in the copper, e.g. coarse crystalline copper structure.

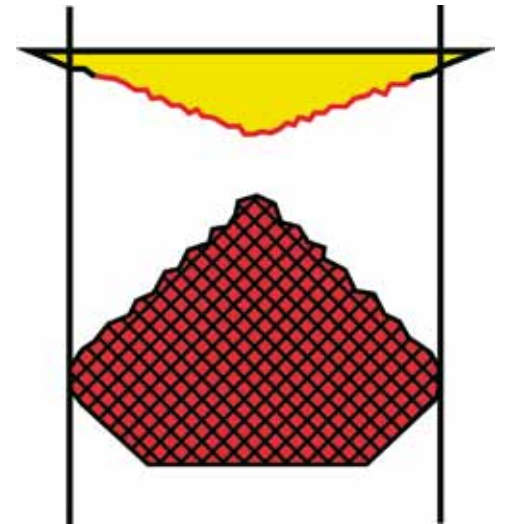
Fine breakages

After a certain period of time, fine notches may be formed on the cutting surfaces which leave groves in the base of the cell during cutting.

Apart from the resulting difficulties in precisely determining the diagonal, the jagged cell walls also have a major effect on ink transfer.

This upsets the relationship between current, cell diagonal and the resulting printing density.

E.g. touching the stylus with your fingers, or if the cutting diamond hits fine abrasive residue (used for polishing the copper surface), impurities in the copper, and attempts to clean the stylus with putty, a brush or compressed air.

The extent of scoring can be determined under the measuring microscope. If the effect of scoring measurably increases on the printing density, no attempt should be made to compensate this using excessive vibration. If the extent of density deviation exceeds the company's own tolerance limits, the only option is to change the stylus.
