Stylus

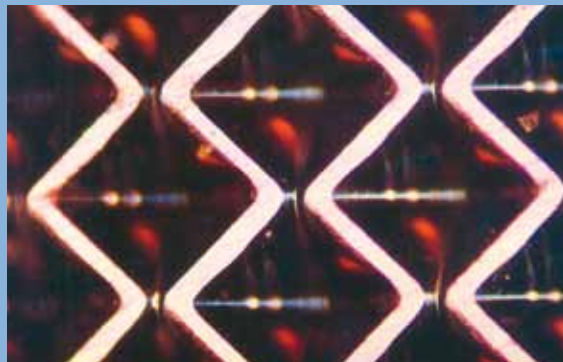
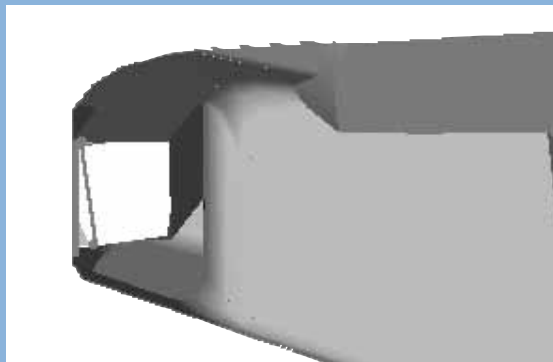
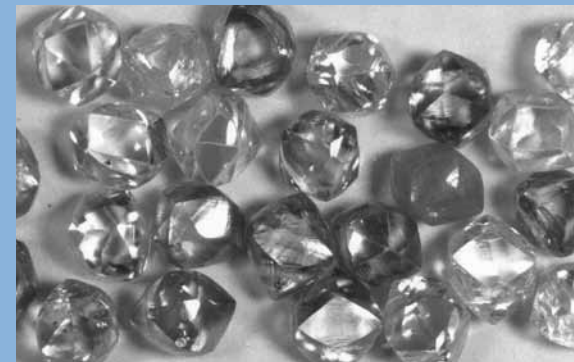
Normal wear

When a diamond stylus is used in the engraving system of a Helioklischograph over a period of time, the mechanical load of the engraving process has a wear effect on the diamond and changes the geometrical shape of it over the time.

Normal wear which affects every mechanical tool is indicated by cratering off the stylus tip. Experiences and repeated stylus analyses have shown wears more at the side (middle section of the stylus) than on the tip itself. The structure of the diamond is the reason for this.

As a matter of course, a change in the stylus geometry has an effect on the cut cell shape and this in turn influences the printing gradation.

If the wear deviation of the separating diamond can no longer be compensated by electronic correction, a new stylus must be fitted. However, whether a stylus can be used up to this point or whether it has to be changed before or after this point has been reached mainly depends on the desired quality of the printing and reproduction results.

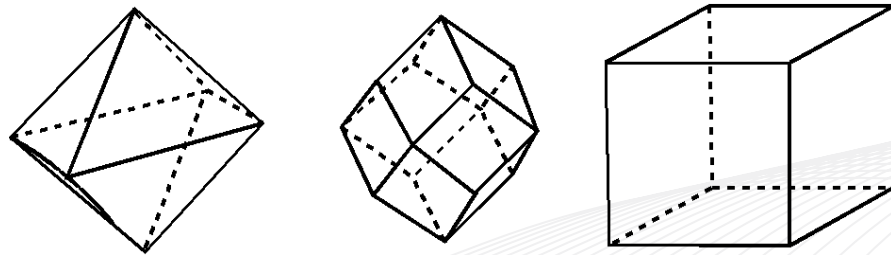
Diamonds may have different crystalline geometries – most frequently octahedrons and rhombic dodecahedrons, very rarely cubic geometries.
